OPTICAL MICROSCOPY AS A SIMPLE METHOD FOR ANALYSIS OF BOILER TUBE FAILURE

Milan T. Jovanović, Zoran Mišković, Vesna Maksimović, Ivana Cvijović-Alagić*

¹ *Department of Materials Science, Institute of Nuclear Sciences “Vinča”,
University of Belgrade, POB 522, 11001 Belgrade, Serbia*

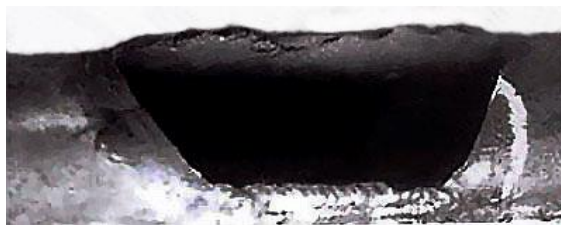
The tube has suffered significant damage (Fig. 1). This type of damage is known as a “window” fracture.

Fig. 1 Damaged boiler tube showing a “window” fracture.

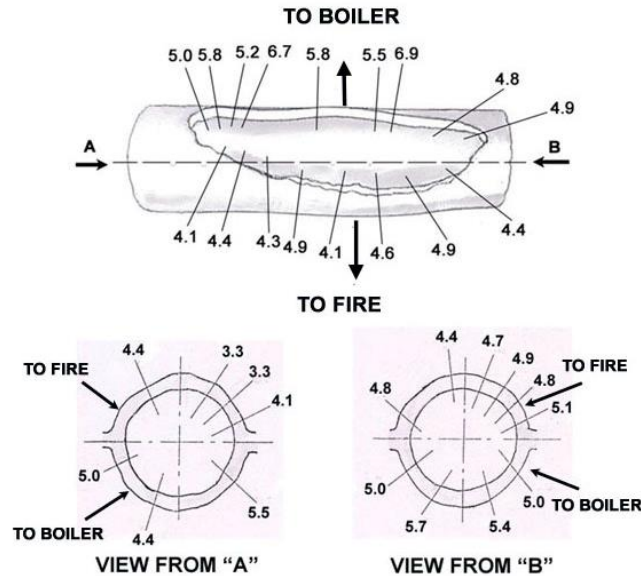
By observing the cross-section of the tube, it can easily be seen that half of the cross-section of the tube segment facing the fire (hereinafter referred to as **F**) was thinner than the part facing the wall of the boiler (marked as **BL**). The measured thickness of the tube walls at different cross-sectional areas is shown in Figure 2.

Fig. 2. The thickness of the tube walls at different cross-sectional areas.

The results of these measurements show that the wall of side **F** is thinner than that of side **BL**. Erosion and corrosion are mechanisms that can cause thinning and subsequent rupture. Overheating may or may not occur in tubes thinned by erosion and corrosion [5].

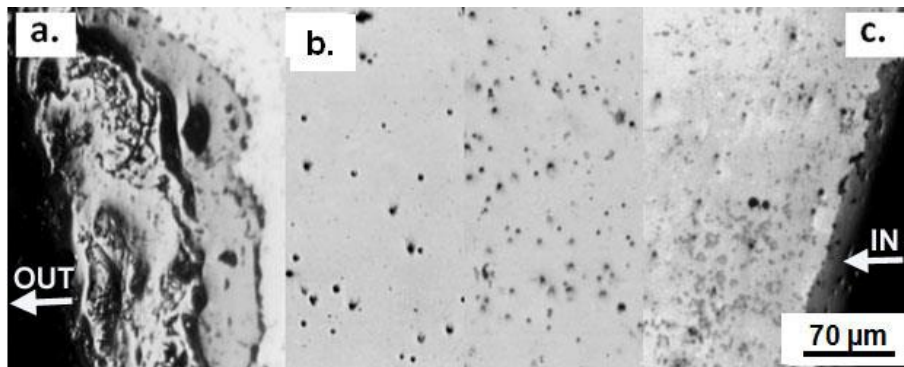
The sample corresponding to section 1a (in Fig. 3b) was only polished (Fig. 4). Oxide layers on the outer and inner part of the side F are clearly visible. The thickness of the oxide layer of the outer surface is much higher (approximately 200 μm) than that of the inner part of the tube (less than 30 μm). This thinning is ascribed to scaling and falling off the oxide due to erosion by cooling water. Inclusions may be seen in the space between the outer and inner walls of the tube.

Fig. 4 Non-etched sample. Oxide layers of section 1a, side F; (marked in Fig 3b); a. Outer wall; b. interior part; c. inner wall.

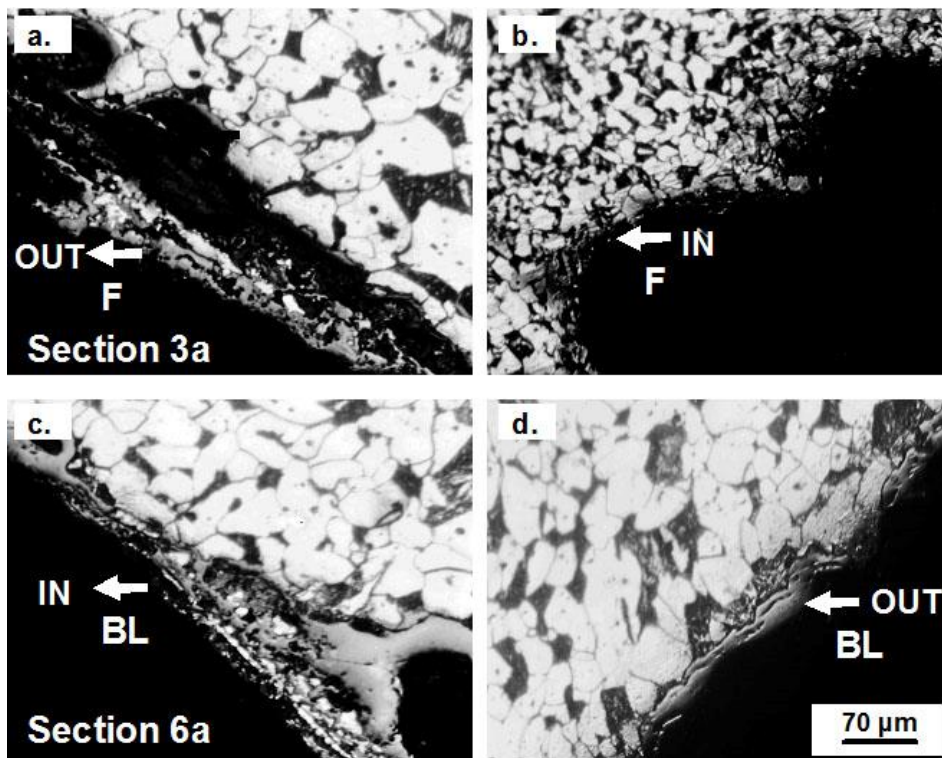
Oxide layers after etching of **F** and **BL** sides (sections **3a** and **6a** in Fig. 3b) are illustrated in Figure 5a-d.

Following the visual inspection, dents and holes may be seen on the inner wall of both **F** and **BL** sides (Fig. 5b, c). These defects appeared as a consequence of the scaling and dropping of oxide debris. A portion of the inner wall of side **F** has a sporadic saw-like shape, which is seen in Figure 5b. It was difficult to detect the presence of oxide on this section of the wall, which indicates that the oxide layer has been removed by erosion. As a result of corrosion, an oxide strip of width between 30 and 70 μm is detached from the surface of the inner wall of side **BL** (Fig. 5c). The outer walls of both sides are covered with an oxide layer and its thickness varies between 5 and 25 μm (side **BL**) and 10 to 40 μm (side **F**). The oxide layer of the outer wall of side **BL** (Fig. 5d) is more compact and uniform than the corresponding oxide layer of side **F** (Fig. 5a). Comparing oxide thickness and morphology from different sections of the tube walls (Figs. 4 and 5) it follows that oxide layers are nonhomogeneous varying in the wide range of thickness. These results also indicate that side **F**, being exposed to a higher temperature, was more prone to oxidation and corrosion processes.

Fig. 5. Etched samples. Oxide layers of sections **3a** and **6a** (marked in Fig. 3b); **OUT** and **IN** denote outer and inner walls of **F** and **BL** sides.

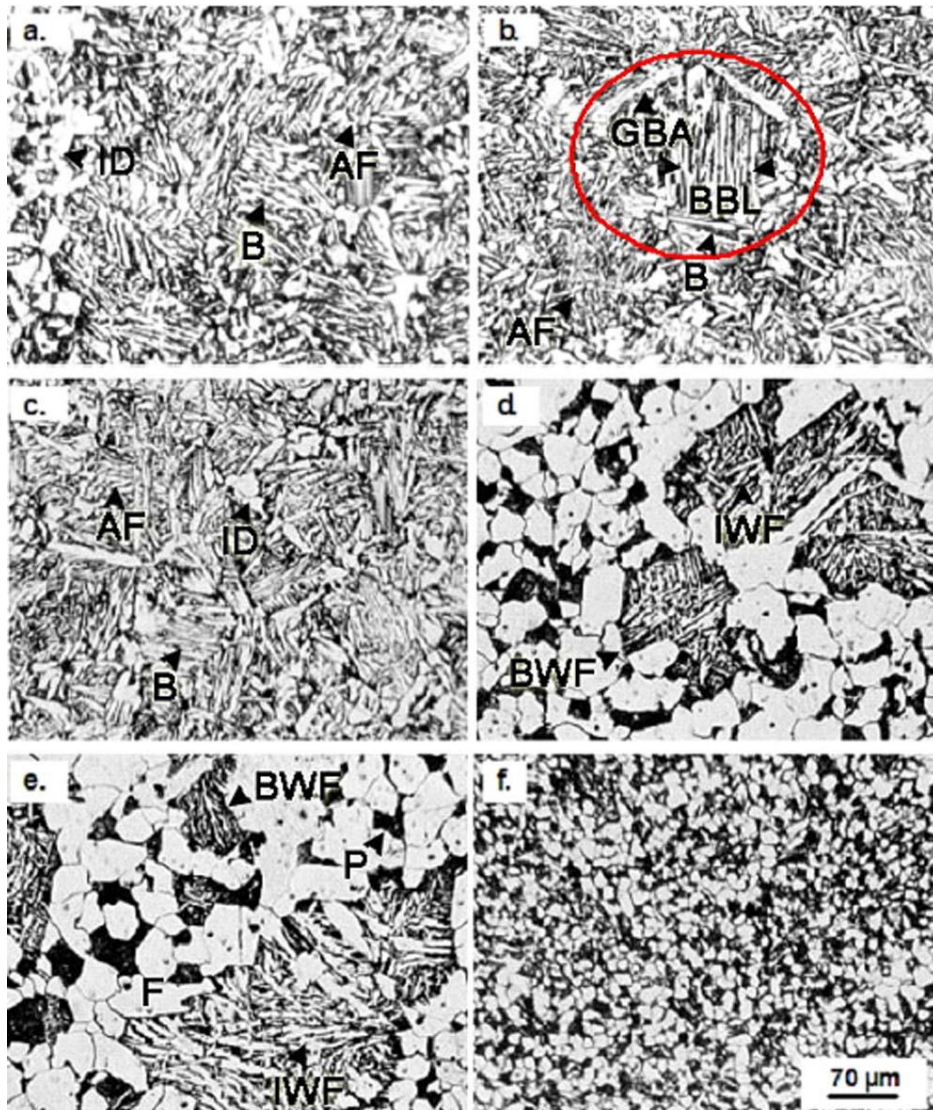
Figure 6(a-f) illustrates microstructural characteristics of side **F** of the segment **A**. Rather heterogeneous structure may be seen in these micrographs.

*Fig. 6 Microstructures of different sections of side **F** of segment **A**. a. and b. section **1A**; c. section **2A**; d. and e. section **3A**; f. section **4A**; (see Fig. 3b). **B**-bainite; **ID**-idiomorphic ferrite; **AF**-acicular ferrite; ring denotes a previous austenitic grain; **GBA**-grain boundary allotriomorphic ferrite; **BBL**-bundles of bainitic laths; **F**-ferrite; **P**-pearlite; **IWF**-intragranular Widmanstätten ferrite; **BWF**-block of Widmanstätten ferrite.*

Acicular ferrite and bainite prevail in Figure 6a, although idiomorphic ferrite is also visible. Bundle of bainitic laths, formed within the previous austenitic grains [6], is present in the central part of section 1A (Fig. 6b). In addition, allotriomorphic grain boundary ferrite also appears in the microstructure, although the presence of a small amount of martensite cannot be excluded. A very similar microstructure exists in section 2A (Fig. 6c).

These results show that a portion of side F was at high temperature, *i.e.* in the single-phase austenitic (γ) region (above temperature A_3). It is possible that at the moment of tube rupture this part of side F (sections 1A and 2A) was exposed to a temperature higher than 870 °C (see position a in Fe-C phase diagram, Fig. 7), and the rapid cooling by the cooling water produced the bainitic transformation. This structure is also present at room temperature.

Microstructures of sections 3A and 4A differ from those of sections 1A and 2A. Actually, the microstructure of section 3A, except polygonal ferrite grains and pearlite, contains blocks in which ferrite has a characteristic morphology (Fig. 6d, e). This type of ferrite, known as intragranular Widmanstätten ferrite, is mostly formed within previous austenitic grains and appears in distinctive blocks [7, 8]. This structure suggests that the sample from section 3 was cooled with the relatively high rate from a temperature corresponding to the two-phase ferrite (α) + austenite (γ) region, above the A_1 transformation temperature (position b in Fe-C phase diagram, Fig. 7). In this region, the primary ferrite begins to develop inside the austenite grains. When the rupture of the tube occurred, water flooded the ruptured area and ferrite in some austenite grains quickly

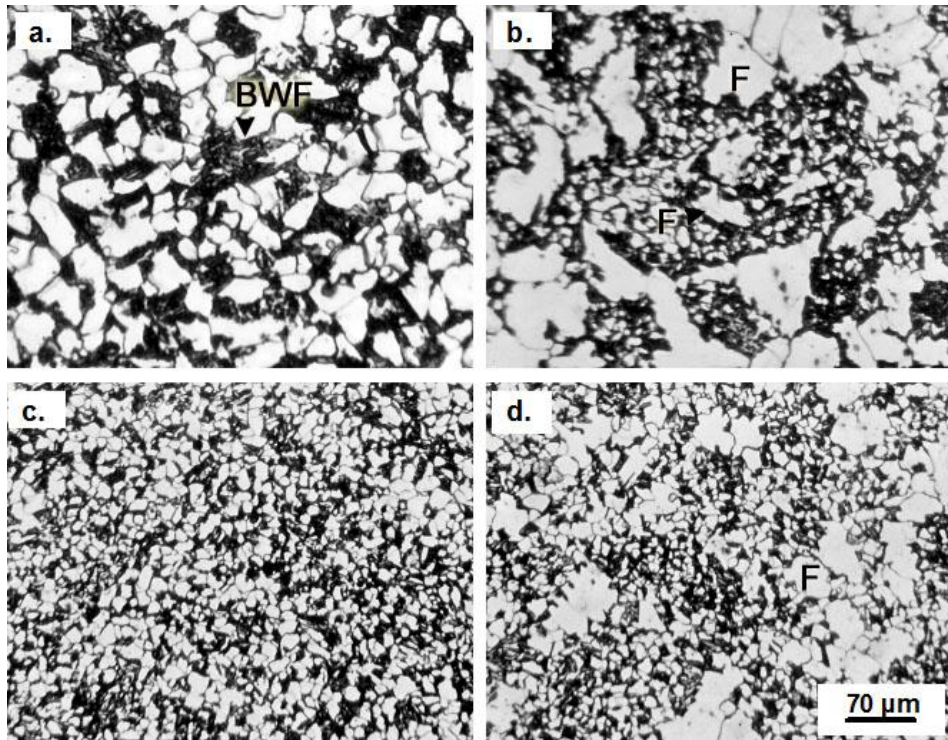
A mixture of different microstructural features is typical for the whole cross-section of side **BL** (Fig. 8a-d).

Fig. 8 Microstructures of different sections of side **BL**. a. and b. section **5A**; c and d section **7A** (see Fig. 3b).

Islands of Widmanstätten blocks in the ferritic matrix appear in section **5A** (Fig. 8a). However, a rather different structure consisting of coarse ferrite and a constituent which might be the remnant of previous massive Widmanstätten block may be seen in the same section. Platelets of small ferrite grains are formed inside this massive block (Fig. 8b). It is not always easy to distinguish these platelets from intragranular Widmanstätten ferrite or idiomorphic ferrite at an optical microscopy level. A very fine mixture of ferrite and pearlite in section **7A** (Fig. 8c) is similar to the microstructure of side **F** (section **4A**, Fig. 8f). Coarse ferrite grains grow at the expense of pearlite (Fig. 8d).

The average hardness of side **BL** is 165HV. Lower hardness and developed microstructures demonstrate that the whole side **BL** was exposed to lower temperatures than the most locations of section **F**.

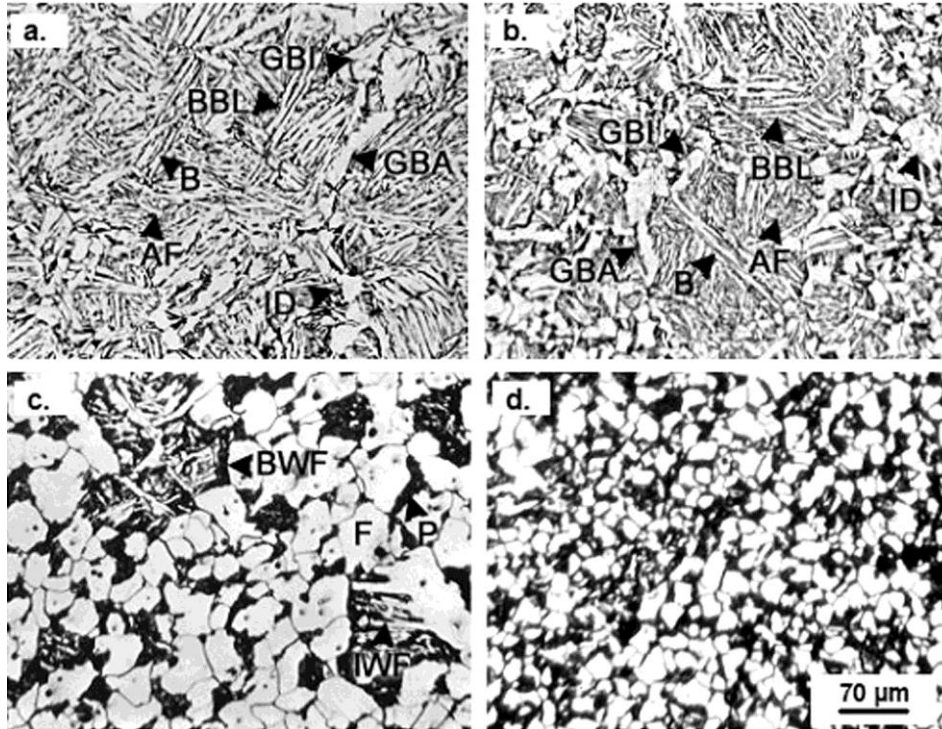
Figures 9a and b show the microstructure after annealing at 980 and 900°C, respectively. The bainitic structure of different forms is mostly present at these temperatures. After cooling from 980°C bainitic bundles are visible in Figure 9a, b. These structures are very similar to those of sections **1A** and **2A** Figure 6(a-c), side **F**. Taking into account possible difference in cooling rates between the massive tube and the small test-sample, it is difficult to determine whether portion of side **F** was exposed just to 900 or 980°C, but similarity between simulated and examined structures cannot be denied. The microstructure of the sample annealed at 800°C contains Widmanstätten blocks, polygonal ferrite grains and pearlite (Fig. 9c). This structure, strongly resembling that of side **F**, section **3A** (Fig. 6d, e), is assumed to originate from the two-phase ferrite-austenite region, possibly near 800°C. Polygonal small-grained ferrite and pearlite (Fig. 9d) indicate that this structure, formed during annealing at 700 °C, was cooled at a somewhat different rate than section **4A**, side **F** (Fig. 6f) and sections **5A** and **7A**, side **BL** (Fig. 8a, b).

In any case, the results of previously described investigation and simulation proved a significant overheating of some parts of segment **A** of the boiler tube.

Fig. 9. Microstructures after annealing and air-cooling. *a, b, c, d* are related to annealing temperatures at 980, 900, 800 and 700 °C, respectively. GBI-grain boundary idiomorphic ferrite.

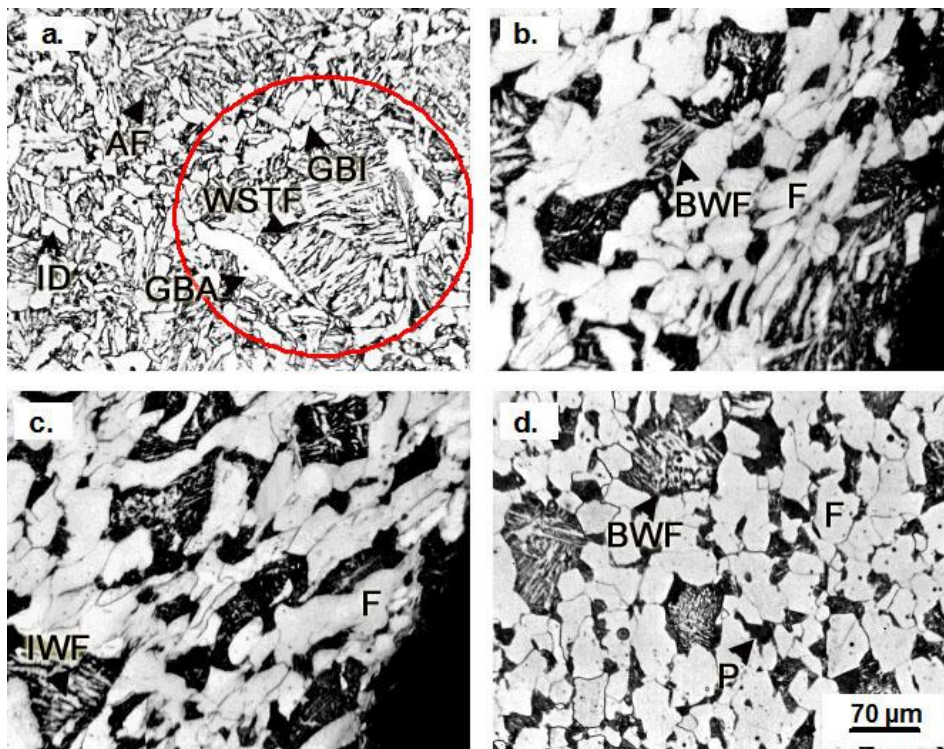
Microstructures of different sections of segment **B** are shown in Figure 10(a-d).

Fig. 10 Microstructure of different sections of segment **B**. a. Side **F** (section **1**); b. and c. side **BL** (section **2**); d. side **BL** (section **3**); (see Fig.3a); ring denotes a previous austenitic grain; WSTF-Widmanstätten saw teeth ferrite.

The microstructure is mostly composed of acicular ferrite and idiomorphic ferrite. Widmanstätten saw-teeth ferrite sideplates [11], nucleated directly at grain boundary allotriomorphs, could also be noticed inside the ring (Fig. 10a, section **1**, side **F**). This structure is typical for a relatively high cooling rate from approximately 900°C. Microstructure related to the opposite side of the tube is quite different and consists of large ferrite grains with some pearlite and Widmanstätten blocks (Fig. 10b, c, section **2**, side **BL**). This structure, which is probably close to the fracture, might be the effect of rapid overheating between A_1 and A_3 temperature and subsequent quenching by cooling water [5], whereas the elongated shape of ferrite grains is the consequence of deformation occurred during fracture. Although the ferritic structure is somewhat depleted on pearlite, it does not imply that the process of decarburization might be active. The microstructure of section **3** is also to some extent, depleted on pearlite (Fig. 10d, section **3**, side **BL**) indicating that a similar cooling rate was active in sections **2** and **3**. These results show that a part of the segment **B**, (section **1**) side **F**, was exposed to a higher temperature than sections **2** and **3**, side **BL**.

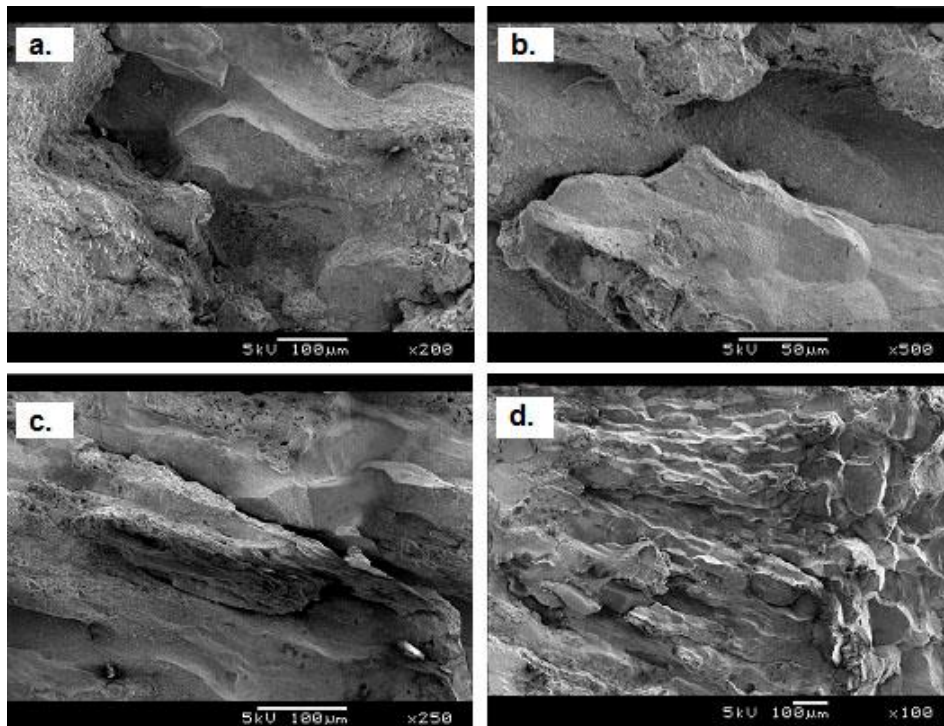
However, only a few microfractographs were successfully obtained and showed a pronounced brittle fracture of the boiler tube, irrespective of the segment location (Fig. 11a-d).

Fig. 11. SEM microfractographs of segment C. a and b section 1; c and d section 2.
