INFLUENCE OF RUNNING CONDITIONS ON RESONANT OSCILLATIONS IN FRESH-AIR VENTILATOR BLADES USED IN THERMAL POWER PLANTS

Original scientific paper
UDC: 692.842:662.612/.613
BIBLID: 0354-9836, 13 (2009), 1, 139-146
DOI: 10.2298/TSCI0901139T

Key words: ventilator, bedding, resonance, fretting

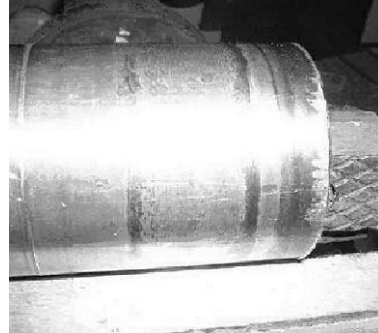
When two pieces of material, pressed together by an external static load (for example, press fits or bolted flanges) are subjected to transverse cyclic loading, so that one contacting face is relatively displaced, parallel to the other face in the presence of high contact stress, wear on the mating surfaces occurs. If the displacement magnitude is less than about 50 μm , the wear is termed “fretting”, fig. 2.

Figure 2. Damaged journal surface caused by fretting

Friction coefficient changed as the consequence of fretting, among other reasons, due to high-frequency cyclic load. Fretting has been the cause of countless failures of the machinery components. One definition describes fretting as: “A special wear process that occurs at the contact area between two materials under load, which are exposed to relative motion by vibration or some other force” [5, 9].

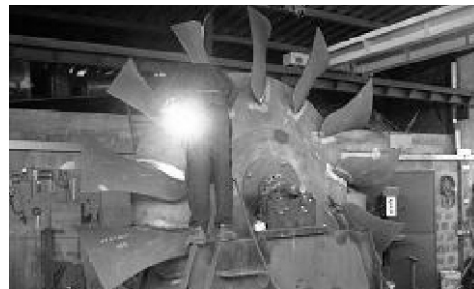
Blades are placed into proper position and partially welded by a special tool. In the end, complete welding of blades root is performed on the rotary positioning device, used for the purpose of putting the ventilator into optimal welding position, fig. 3. This process can also put some allowed errors in real shape of the ventilator. That geometry imperfections cause unbalanced centrifugal forces and different natural frequencies of the body segments and all blades.

Figure 3. Ventilator production – welding of blades

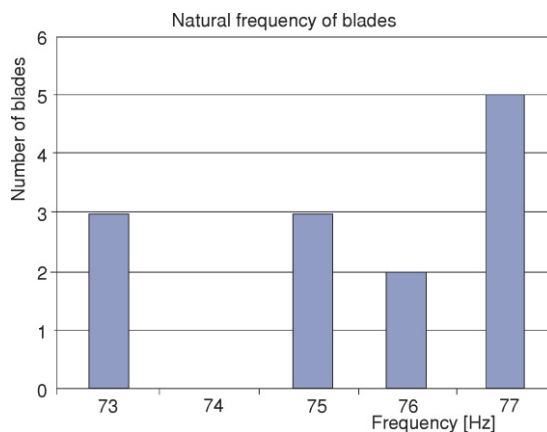
Figure 5. Measured values of blade's natural-frequencies

Figure 5 shows several ventilator blades with the same natural-frequency values. The measurements were done on one of the produced primary stage air ventilators.

The ventilator has 13 blades. Three of them have natural frequency of 73 Hz, other three 75 Hz, two 76 Hz, and five 77 Hz. This points out the importance that the final product – ventilator with controlled dynamic characteristics – can not be produces just according to technical drawings, prescribed welding technology and thermal treatment, but that it is essential to adjust the blades dynamical characteristics experimentally, adding or removing mass on top of the blades.

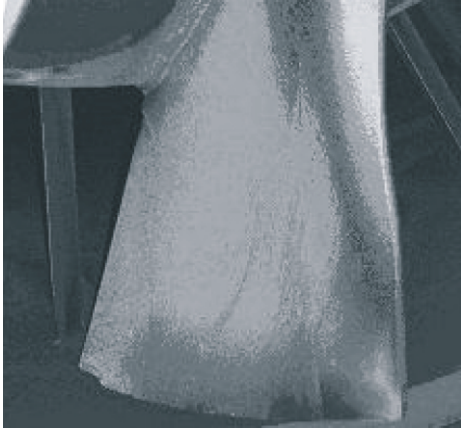
During the exploitation time, erosion of the blades takes place, especially in the area with highest drift speed. Abrasion is performed by dust and sand, fig. 6.

Figure 6. Damaged blade zones

It is possible to perceive that the blade edge is damaged, especially on the top of aero profile front edge. The rear edge is missing a piece of the material.

Mass decrease on blade edges leads to increase of natural-frequency, so even already adjusted blade gets into the situation that its natural-frequency can match some harmonics of the ventilator electro-motor basic speed revolutions.

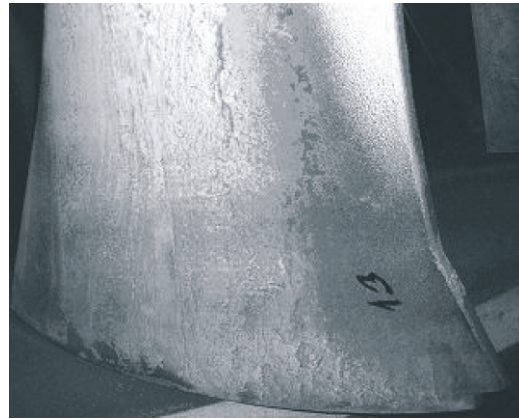
Figure 7. Blade surface with attached layer of dirt

Figure 7 shows appearance of the blade on the surface of which a layer of dirt is attached, increasing the mass and decreasing its natural frequency.

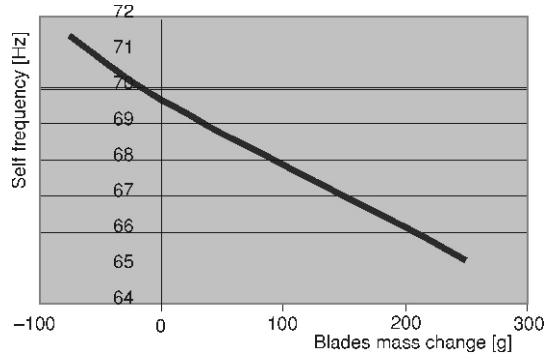
ing to the results [2], it is possible to define sensitivity of natural frequency change to mass change of the blade's top. This change is shown in fig. 13. It can be perceived that a relatively small mass change (ca. 200 g) of the blade, which has 50 kg in total mass (0.4%), changes the natural frequency by ca. 6% .

Figure 13. Influence of blades top mass change on its natural frequency

Blade natural frequency in actual running conditions is changeable and depends on fabrication tolerance, strains, layers of dirt, and erosion process. The influence of mass change on natural frequency is shown by numerical simulations. It has been confirmed by experiment that 0.4% of mass change on blades top changes natural frequency by 6%. Therefore, erosion or dirt layers during operation change blades natural frequencies and can cause resonant oscillations and fretting wear in the overlaps in the bedding.

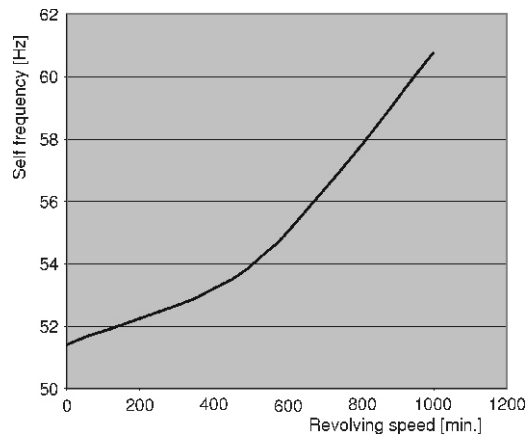
Strains increase in the direction of the blades top. Rotation simulations were performed to estimate this influence, with different revolving speed, starting from 0, 450, 740 up to 1000 per minute. Results are shown in the diagram on the fig. 14.

It is visible that the change in revolving speed has smaller influence on ventilator's natural frequency than the mass change. Change of the revolving speed by 21%, changes the natural frequency by 2 Hz (3.5%).

Figure 14. Influence of revolving speed

It has also been confirmed that strain in blades, as the consequence of centrifugal forces, also has certain influence on the value of natural frequencies. Change of the revolving speed by 21% changes natural frequency by 3.5%. When blades are adjusted during production process, possible change of shaft revolving speed during operation has to be taken into consideration.
