OPTICAL MICROSCOPY AS A SIMPLE METHOD FOR ANALYSIS OF BOILER TUBE FAILURE

Milan T. Jovanović, Zoran Mišković, Vesna Maksimović, Ivana Cvijović-Alagić*

¹ *Department of Materials Science, Institute of Nuclear Sciences “Vinča”,
University of Belgrade, POB 522, 11001 Belgrade, Serbia*

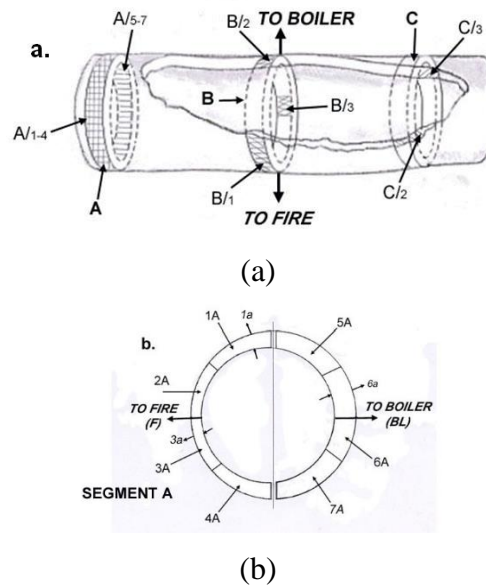
The method of cutting and marking of samples for microstructural examination is shown schematically in Figure 3a. Also, a schematic presentation of the cross-section of segment **A** with marked sections of individual samples is presented in Figure 3b. Sections from **1-4A** (toward fire **F**) and **5-7A** (toward boiler **BL**) indicate the locations on the cross-section of the segment that were examined using an optical microscope.

Fig. 3. a. Method of sampling and marking for microstructural examinations; b. schematic presentation of a cross-section of segment A with marked sections: section 1a (non-etched oxide layer); sections 3a and 6a (etched oxide layer).

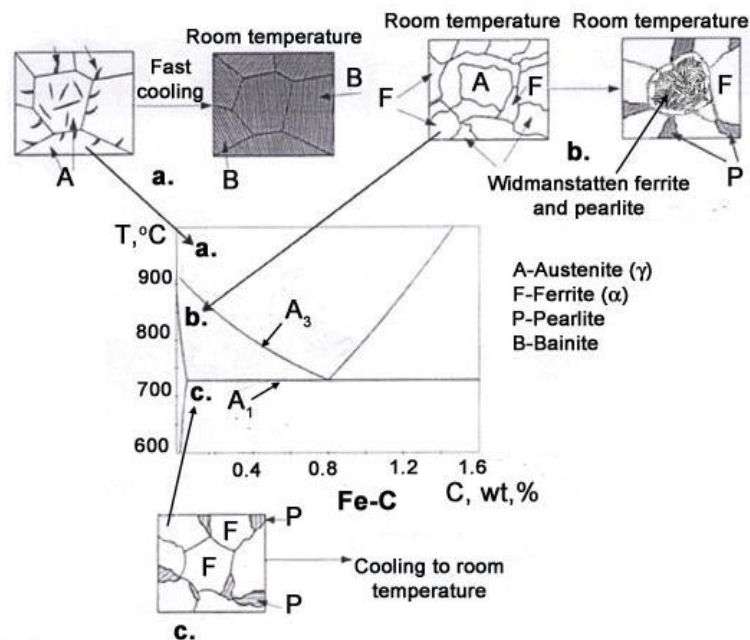
These results show that a portion of side F was at high temperature, *i.e.* in the single-phase austenitic (γ) region (above temperature A_3). It is possible that at the moment of tube rupture this part of side F (sections 1A and 2A) was exposed to a temperature higher than 870 °C (see position a in Fe-C phase diagram, Fig. 7), and the rapid cooling by the cooling water produced the bainitic transformation. This structure is also present at room temperature.

Fig. 7 Schematic presentation of expected microstructural features after cooling from different temperatures.

grew into some preferred orientations inside the grain forming laths and plates of Widmanstätten ferrite that tend to be aligned along the same direction within one grain [9]. Below A_1 temperature, the remaining austenite transforms into a fine and rather messy pearlite, and Widmanstätten block reaches its final morphology. Note that almost in each ferrite grain, at least one inclusion is visible. These inclusions serve as nucleation centers (seeds) for the formation of proeutectoid acicular ferrite in the region above the A_3 transformation temperature [10]. The location of side **F**, corresponding to section **4A**, is distinguished by completely different structure (Fig. 6f). A very fine-grained ($\sim 10\mu\text{m}$) ferritic-pearlitic structure may be seen. It may be supposed that a part of side **F** was exposed to a temperature in the high two-phase ferritic-pearlitic region (see position **c** in Fig. 7), and then was cooled at a higher rate, so the fine-grained structure was obtained.
